# All Build Home Inspections

## Property Inspection Report

54 Main Street , Cochrane, AB, T4A 1G3

Date of Inspection: 6/4/2025 Time: 9:00am

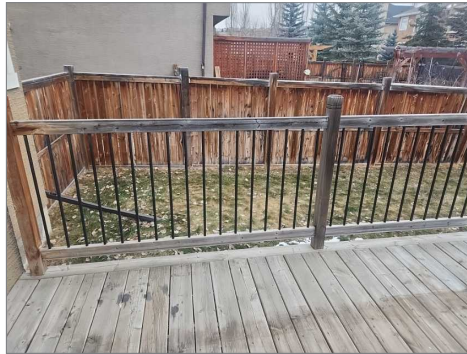
| Lots and Grounds | | |
|---|---|---|
| Page 6 Item: 4 | Deck | 4.1. Deck guardrail assemblies were loose and should be repaired by a qualified contractor. |

4.1. Deck guardrail assemblies were loose and should be repaired by a qualified contractor.

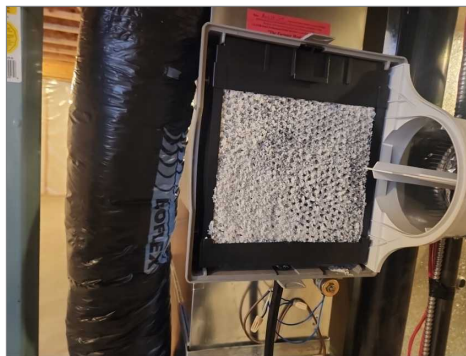
| Lots and Grounds | | |
|---|---|---|
| Page 21 Item: 9 | Humidifier | 9.1. Heavy calcium buildup observed on filter. These filters should be changed every six months for proper operation. This filter needs to be changed or could lead to unwanted backups. |

9.1. Heavy calcium buildup observed on filter. These filters should be changed every six months for proper operation. This filter needs to be changed or could lead to unwanted backups.

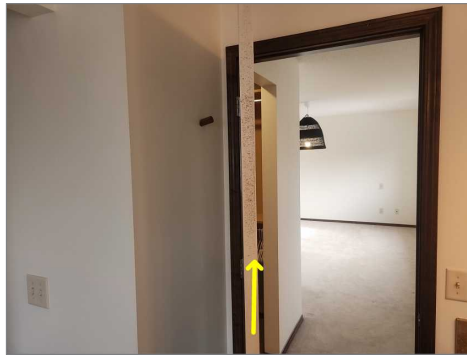
Primary

5.1. The door has some minor damage that has not affected the operation.

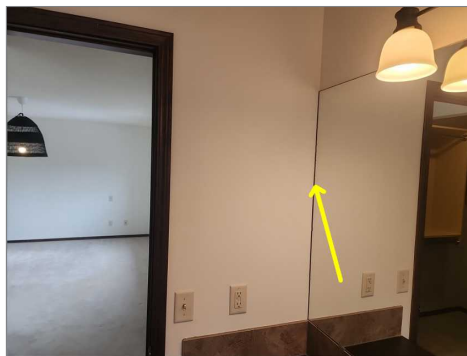
Primary

| Lots and Grounds | | |
|---|---|---|
| Page 28 Item: 9 | Mirrors | 9.1. The mirror is chipped. The sharp edges could be potential laceration hazard to anyone who touches it. Recommended replacing the mirror. |

9.1. The mirror is chipped. The sharp edges could be potential laceration hazard to anyone who touches it. Recommended replacing the mirror.

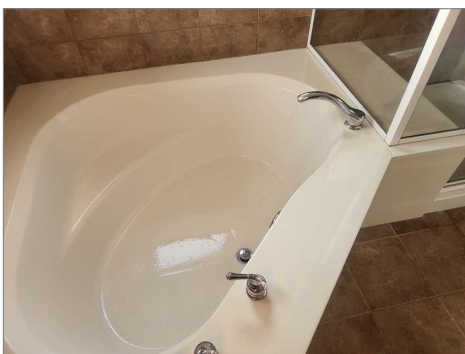
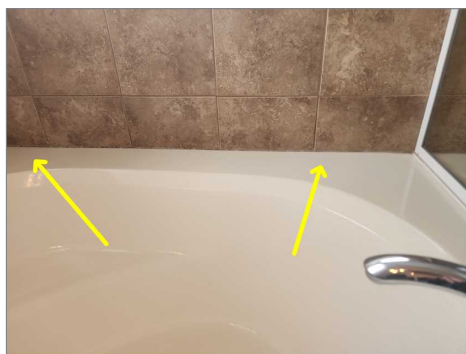
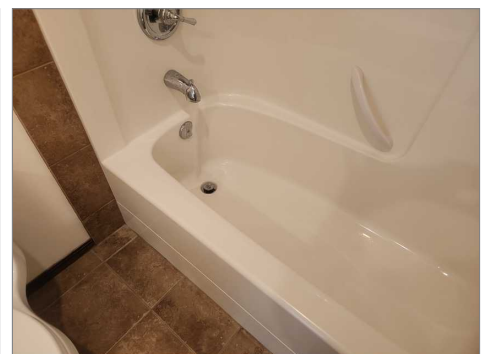
| Lots and Grounds | | |
|---|---|---|
| Page 29 Item: 14 | Tub / Surround | 14.1. IMPROVE: Suggest all tile edges and tub/shower walls be caulked and sealed to prevent moisture penetration. All missing/damaged grouting should be replaced. Failure to keep walls sealed can cause deterioration and extensive moisture damage to the interior walls and surrounding sub-flooring. This damage is not always visible or accessible to the inspector at the time of inspection. |

14.1. IMPROVE: Suggest all tile edges and tub/shower walls be caulked and sealed to prevent moisture penetration. All missing/damaged grouting should be replaced. Failure to keep walls sealed can cause deterioration and extensive moisture damage to the interior walls and surrounding sub-flooring. This damage is not always visible or accessible to the inspector at the time of inspection.

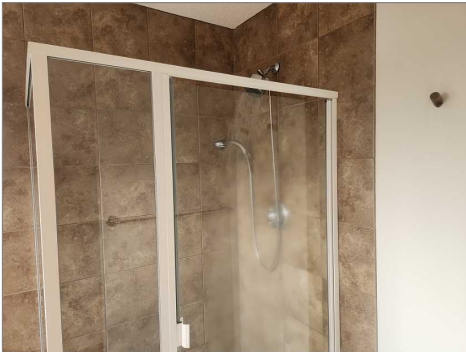
Primary

| Lots and Grounds | | |
|---|---|---|
| Page 30 Item: 15 | Shower / Surround | 15.1. NOTED: A leak was noted where shower surrounds meets the wall. This requires further evaluation and repair (likely just new caulking) by a suitable professional. |

15.1. NOTED: A leak was noted where shower surrounds meets the wall. This requires further evaluation and repair (likely just new caulking) by a suitable professional.

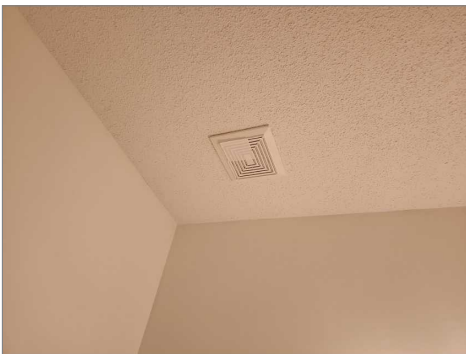
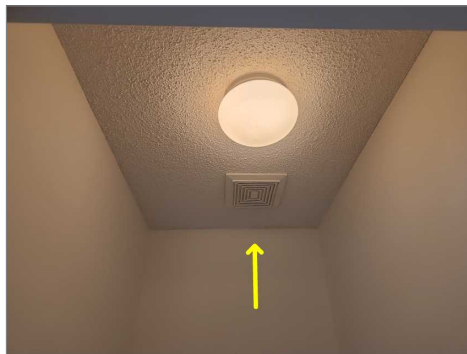
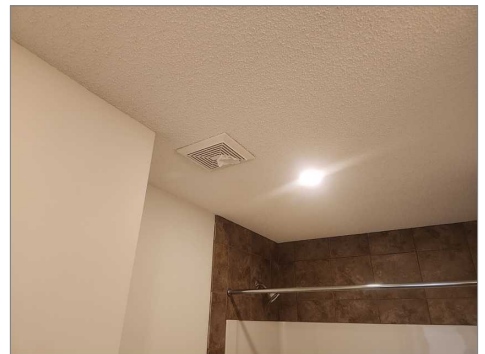
| Lots and Grounds | | |
|---|---|---|
| Page 30 Item: 16 | Exhaust Fan | 16.1. The bath fan did not operate when tested. Recommend further review and evaluation by qualified HVAC tech. |

16.1. The bath fan did not operate when tested. Recommend further review and evaluation by qualified HVAC tech.

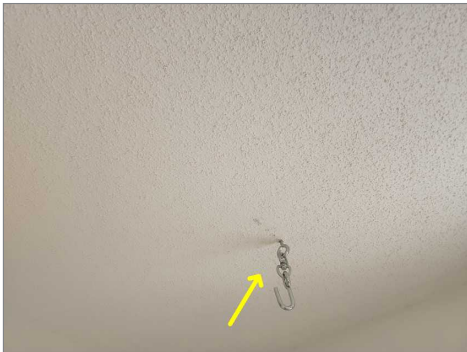
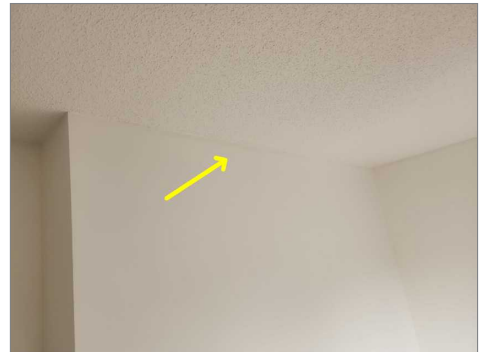
3.1. Settlement cracks noted in ceiling. These are typical and should be monitored for any change.

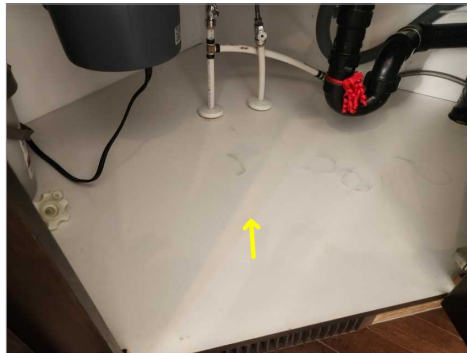
Evidence of past leakage, dry at time of inspection

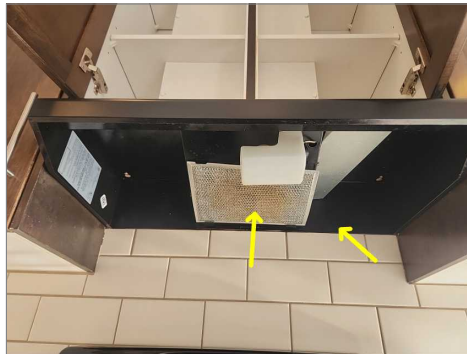
14.2. Light not working. Recommend changing bulb(s) and retesting.

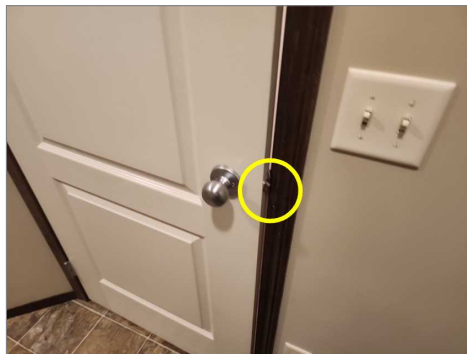
| Lots and Grounds | | |
|---|---|---|
| Page 36 Item: 6 | Doors | 6.1. Door was binding on the jamb and would not close. Requires trimming or adjustment. The Inspector recommends correction by a qualified contractor. |

6.1. Door was binding on the jamb and would not close. Requires trimming or adjustment. The Inspector recommends correction by a qualified contractor.

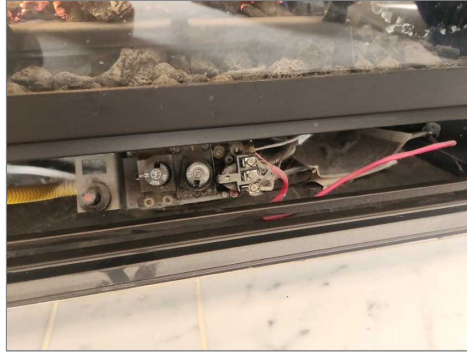
2.1. Suggest cleaning this area as a built-up of lint and debris can be a fire hazard.
