# All Build Home Inspections

## Property Inspection Report

54 Main Street , Cochrane, AB, T4A 1G3

Date of Inspection: 6/4/2025 Time: 9:00am

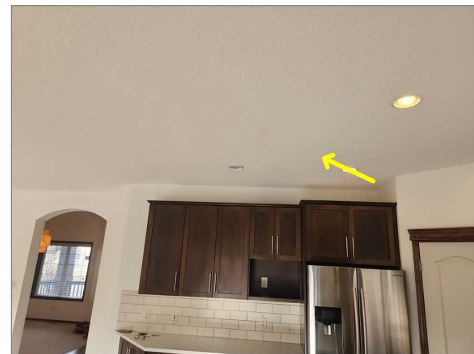
Ceiling staining- No abnormalities detected
