# All Build Home Inspections

## Property Inspection Report

54 Main Street , Cochrane, AB, T4A 1G3

Date of Inspection: 6/4/2025 Time: 9:00am

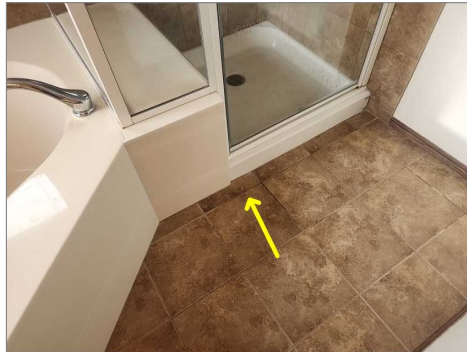
Primary

15.1. NOTED: A leak was noted where shower surrounds meets the wall. This requires further evaluation and repair (likely just new caulking) by a suitable professional.

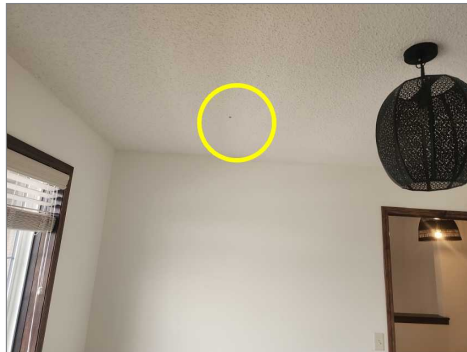
East

3.1. Settlement cracks noted in ceiling. These are typical and should be monitored for any change.

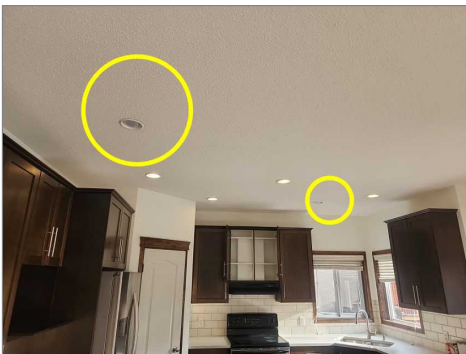
Ceiling staining- No abnormalities detected

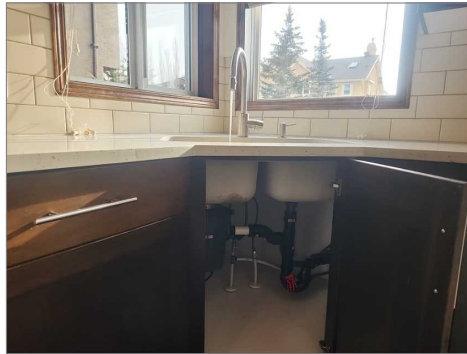
Evidence of past leakage, dry at time of inspection
